Fixing the buzz Steps 1-2

18. You are now done fixing the buzz problem on your Twentieth Anniversary Macintosh. Plug everything back in and try it out. You should be able to enjoy it once again. Keep in mind that this is NOT a permanent fix, and you may need to repeat this process in the future.

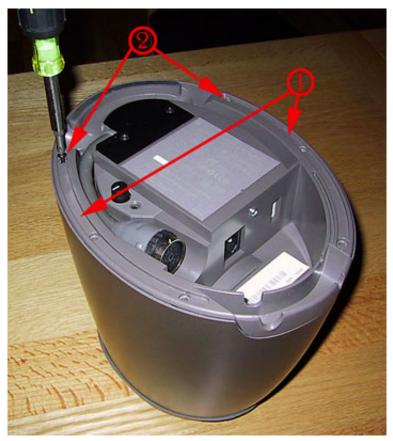
- 1. Remove the rubber strips on the bottom of the Bose unit.
- 2. Remove the screws from the bottom of the Bose unit.

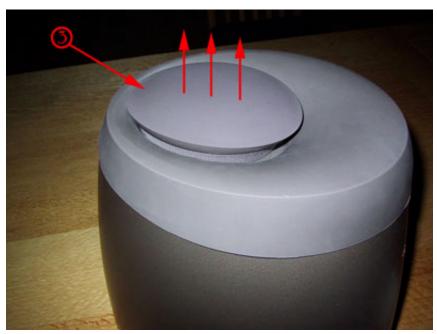
3. Remove the small, inner cover on the Bose unit. It just pops straight up. There are no screws or fasteners.

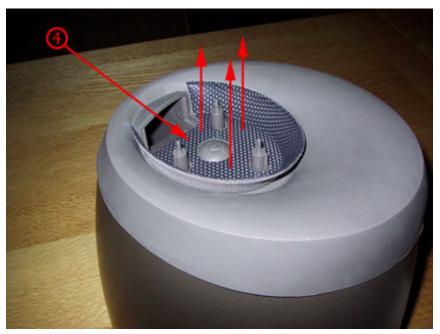
4. Remove the small plastic piece in the center. It should just be sitting there. If you don't, it will fall off when you turn the Bose unit over, and you will probably crush it.

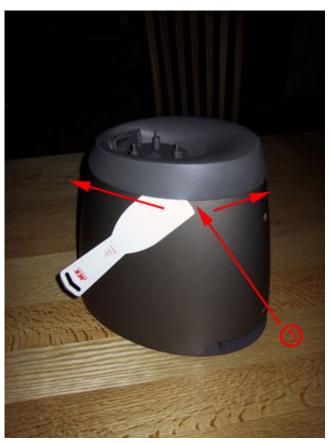
5. Use a small, thin, plastic piece to slip under the rubber cover of the Bose unit. Be sure to use something that won't scratch the surface of the Bose unit. I chose a plastic putty knife so it wouldn't mar the finish. The idea is to separate the rubber from the plastic. It is glued on with a substance that looks like rubber cement. So you will probably need to go around the entire unit to make sure it is loose.

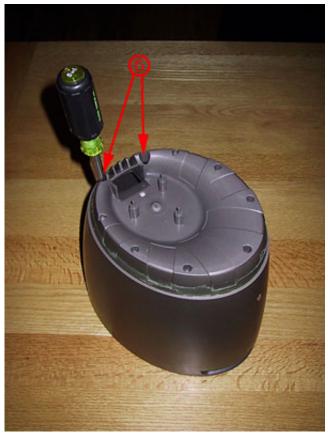
6. Remove the two screws that holds the plastic case together.

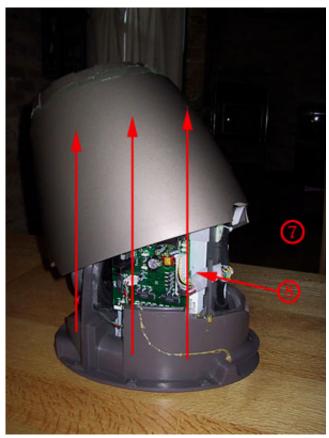
- 7. Remove the plastic cover to the Bose unit. It should lift straight up.
- 8. Note the location of the connector for step 8.

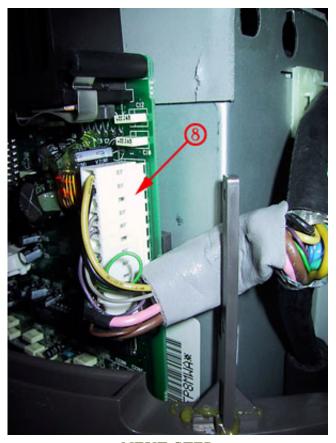
8. This is the connector that causes the buzzing noise. You will need to disconnect it from the circuit board. See step 9 before you attempt to disconnect it.

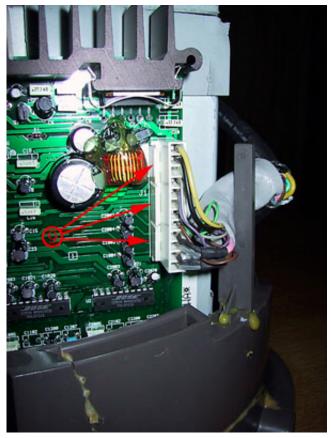
9, These tabs are holding the connector to the circuit board. You may need to *carefully* pry them back in order to disconnect the cable. This part is pretty tricky.

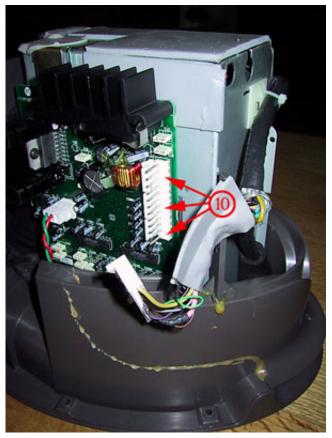
10. Use a pencil eraser to clean the posts on this connector. The buzz is caused by oxidation on the connector. Once cleaned, the buzz will go away. For how long? I don't know. Mine has been buzz-free for several months now. *

Be very careful at these next stages. Static electricity can ruin the components on the circuit boards. High voltages can also be stored in the power supply and capacitors. You could get shocked, so be careful not to touch anything that you don't need to touch...

* A permanent fix involves tinning the power and speaker connector leads to pervent future oxidation. For details, see:

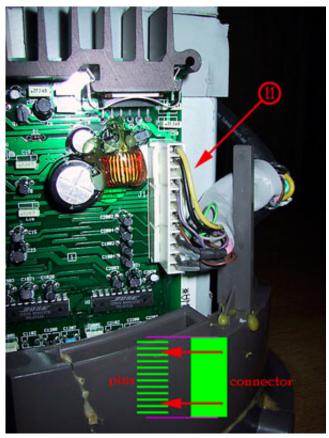
11. Replace the connector, being careful that it is properly lined up and all of the pins are in the right place. It is possible to connect it and not have the pins lined up. If you do, you will damage your computer. Double check to make sure it is back in correctly.

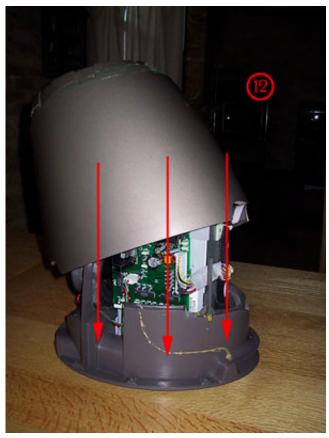
12. Put the top cover back on. Make sure everything lines up properly.

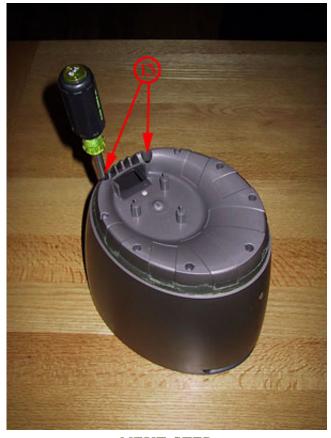
13. Replace the screws in the top cover. Hand tighten, but not too tight.

Also put the rubber top on the Bose unit. I didn't take a picture of this step. But it isn't that hard to figure out where it goes. Make sure it is lined up correctly, then press the sides back down. I didn't use any glue on mine, it is just sitting on top. Only because I expect to have to repeat this process in 6 to 12 months... So don't use any glue unless you feel like you will never have to open it again.

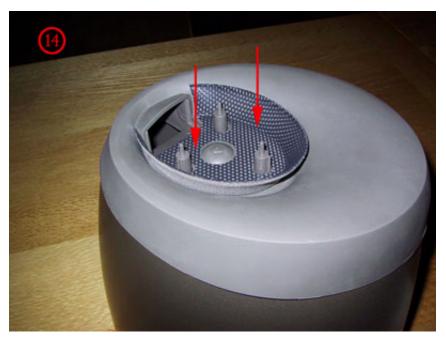
14. Put the top speaker grille back in place. It doesn't fasten, it just sits there.

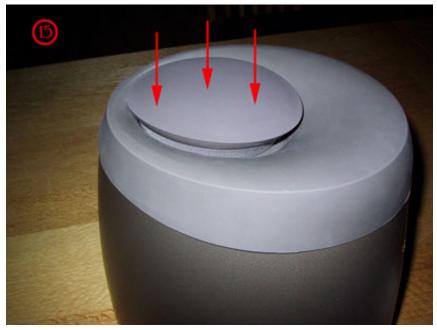
15. Replace the top cover. It might take a little pressure to put it on. Make sure the holes are lined up properly. And don't press too hard. Just enough to secure it to the top.

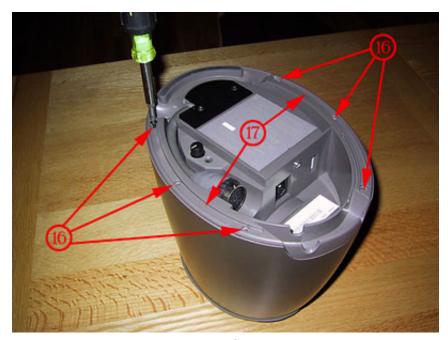
- 16. Put the screws back in the bottom cover. Hand tighten, but not too tight. You don't want to strip the threads. Remember, the base is plastic, not metal threads.
- 17. Replace the rubber feet. If they don't stick, you might want to put a little bit of rubber cement on them first. But don't use any strong glue (like Epoxy or SuperGlue) to attach them. If you do, you will have a *very difficult* time getting them off without ruining them.
